Memorandum

From : Department of Fish and Game

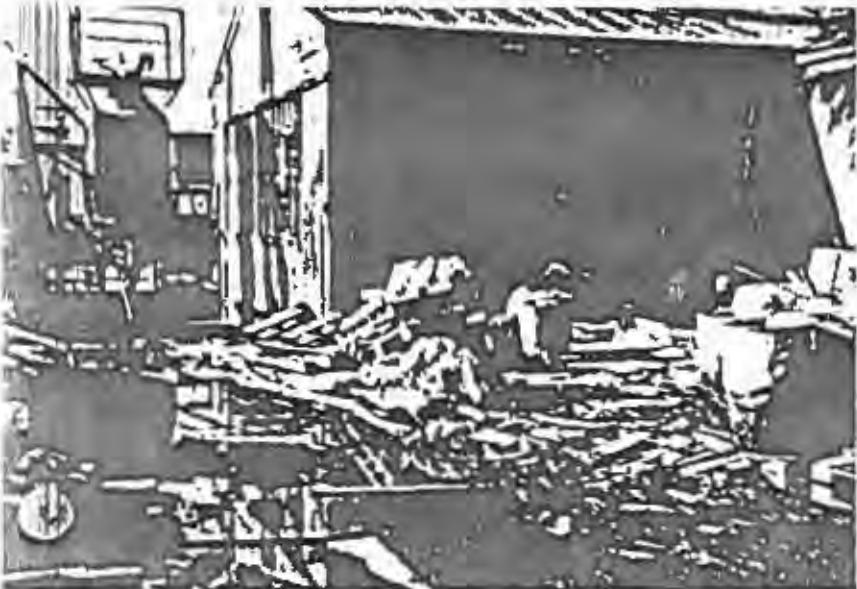
The picture on the left is the area used by the plant , care was not taken to prevent the rains from washing the powder DDT from the bags, and then run into the water of the channel. there were other types of insecticides on the area.
